# Coal Combustion Waste Impoundment Dam Assessment Report

## *Site 25*

### *Fly Ash Pond & Bottom Ash Pond American Electric Power Philip Sporn Generating Plant New Haven, West Virginia*

#### **Project # 0-381**

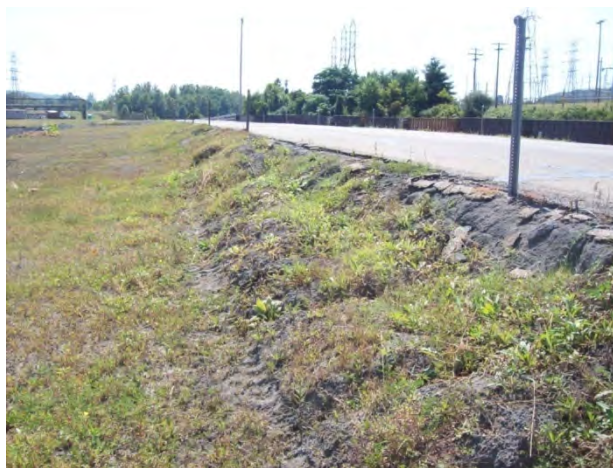
Bottom Ash Pond - The upstream slope is sparsely vegetated with tall grasses and other wetland vegetation. Scarps, sloughs, depressions, bulging or other indications of slope instability were not observed. Erosion, most likely caused by storm water runoff from the road system along the crest, was observed along the northwest dike and is beginning to undermine the paved road.

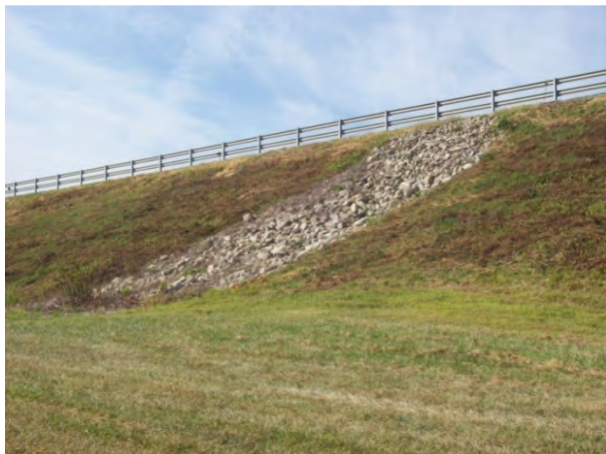
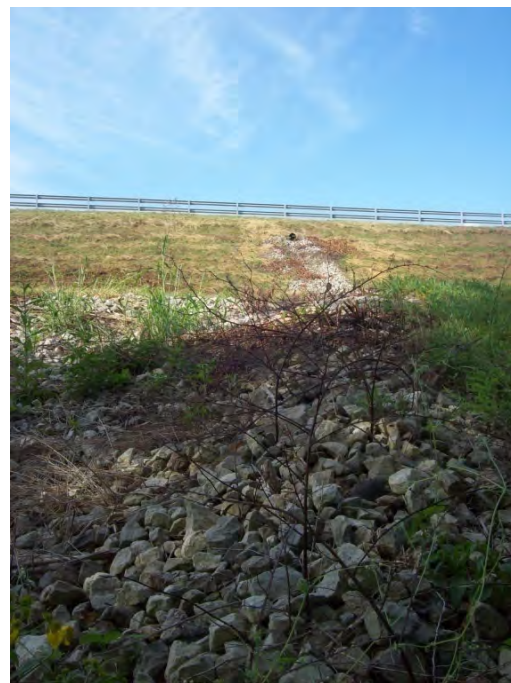
Fly Ash Pond – The highest embankment is along the east dike parallel to the Ohio River. The east dike is mostly grassed with a section of rip-rap placed to mitigate previous erosion resulting from point discharge of a storm drain along a roadway.

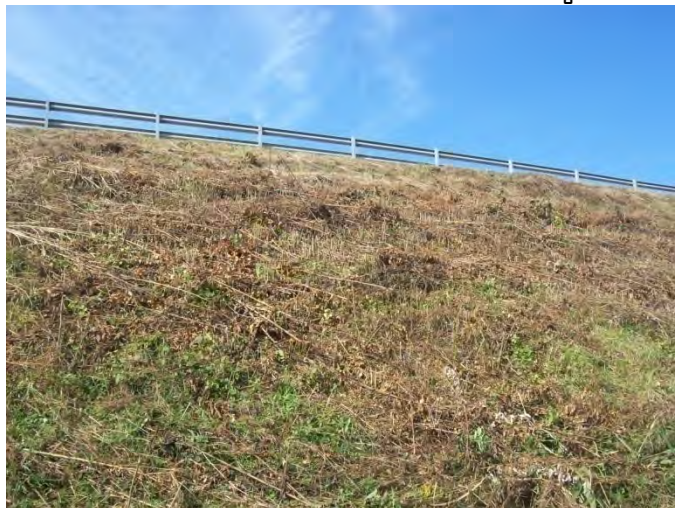
Isolated areas of the eastern dike have surface irregularities consistent with past surface sloughing.

- Perform remediation along downstream slopes to address sloughing and assess the effect of railway-induced ground vibrations on embankments.
- Perform slope stability analyses under earthquake loading conditions for the upper sections of the eastern dike.
- The potential for liquefaction of embankment and foundation soils needs to be studied.

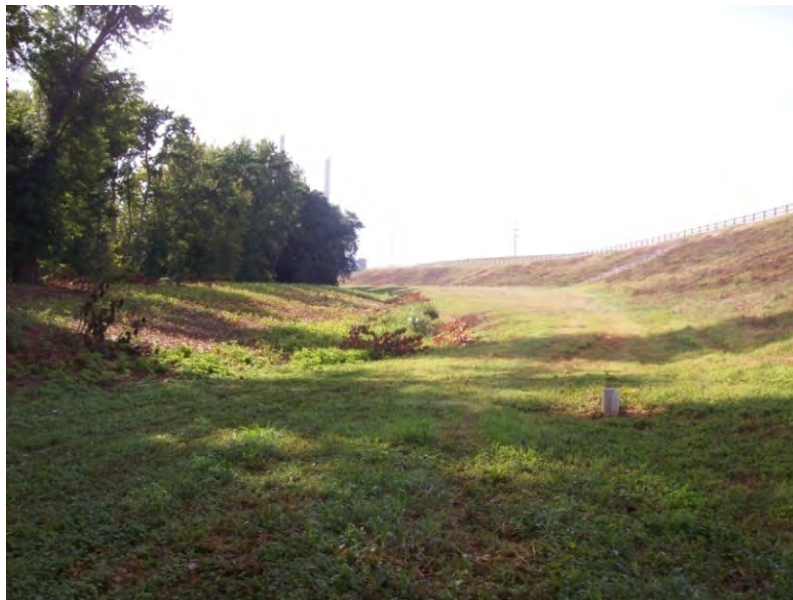
Standing water and wetland vegetation was present downstream of, and near the toe of, the eastern dike embankment.

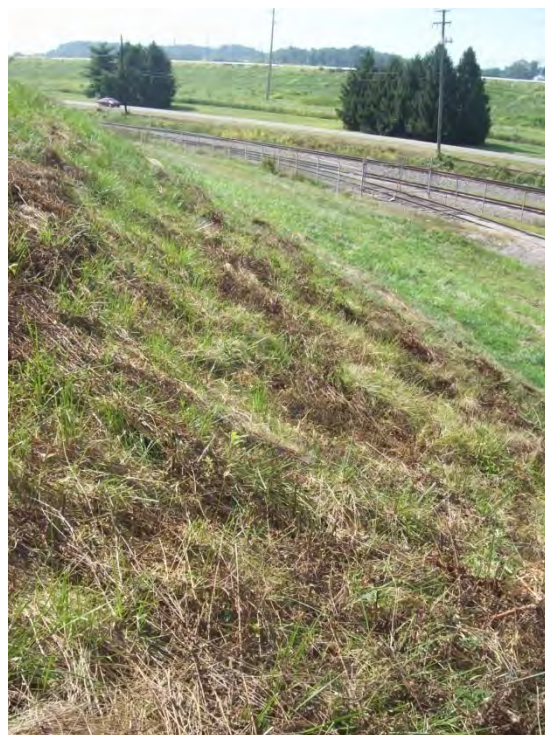
The western dike paralleling the railroad is mostly grassed with some portions covered by rip-rap. Much of the grassed embankment along the west dike is experiencing active surface sloughing. The north and south diked embankments are grassed and no sloughing or erosion was observed. None of the diked embankments showed evidence of scarps, depressions, bulging or other indications of deep slope instability.

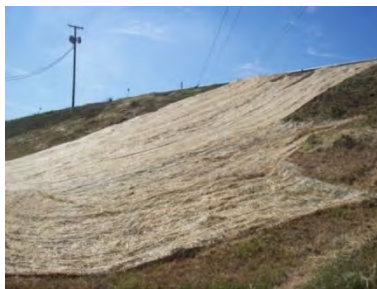
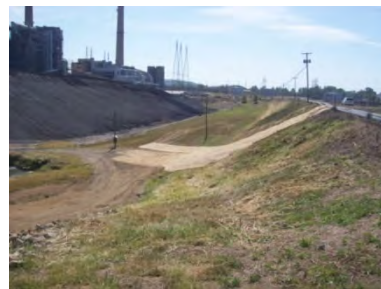
Bottom Ash Pond - The highest embankment impounding the Bottom Ash Pond is along the east dike parallel to the Ohio River. The upper section of the east dike is mostly grassed with a section of straw matting

placed to facilitate grassing and mitigate erosion resulting from roadway storm water runoff. Isolated areas of the upper eastern dike have surface irregularities consistent with past surface sloughing.
